[Docket No. FAA-2016-4674; Directorate Identifier 2016-SW-001-AD; Amendment 39-18835; AD 2017-06-11]

Airworthiness Directives; Airbus Helicopters

SUMMARY: We are superseding Emergency Airworthiness Directive (Emergency AD) 2015-24-51 for Airbus Helicopters Model EC120B. Emergency AD 2015-24-51 required inspections of the air conditioning system. This supersedure revises the applicability, some of the terminology, and the inspection requirements. This AD was prompted by a report of an abnormal noise during flight of a Model EC120B helicopter that resulted in a precautionary landing. We are issuing this AD to prevent an unsafe condition on these products.

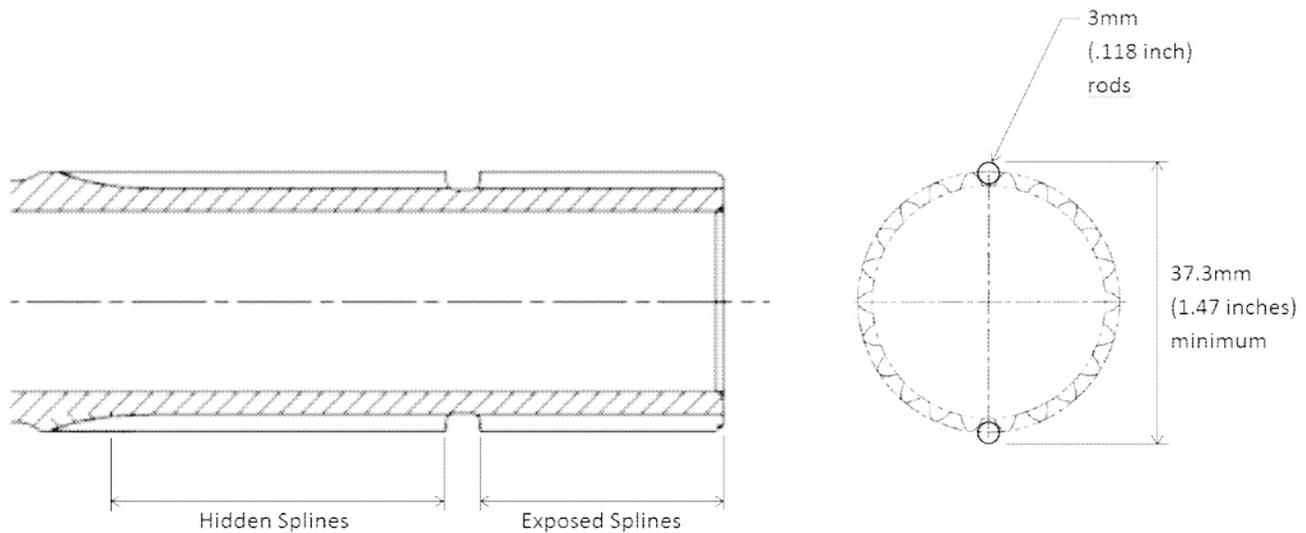
(ii) Inspect the exposed portion of each wheel spline for cracking, scoring, metal pick-up, and wear by using Figure 1 to paragraph (f)(1)(ii) of this AD. To inspect for wear, position two 3 mm

(0.118 inch) rods in all diametrically opposed splines and measure to determine whether there is a minimum of 37.3 mm (1.47 inches) across the outside diameter of the rods. If there is any cracking, scoring or metal pick-up, or if a measurement is less than 37.3 mm, replace the wheel.
